MARINE CASUALTY REPORT

MOBILE OFFSHORE DRILLING UNIT (MODU) OCEAN RANGER, O.N. 615641, CAPSIZING AND SINKING IN THE ATLANTIC OCEAN, ON 15 FEBRUARY 1982 WITH MULTIPLE LOSS OF LIFE

REPORT NO. USCG 16732/0001 HQS 82

**REPORT OF THE U.S. COAST GUARD
MARINE BOARD OF INVESTIGATION CONCERNING
THE MODU OCEAN RANGER, O.N. 615641;
CAPSIZING AND SINKING IN THE ATLANTIC OCEAN
ON 15 FEBRUARY 1982 WITH MULTIPLE LOSS OF LIFE**

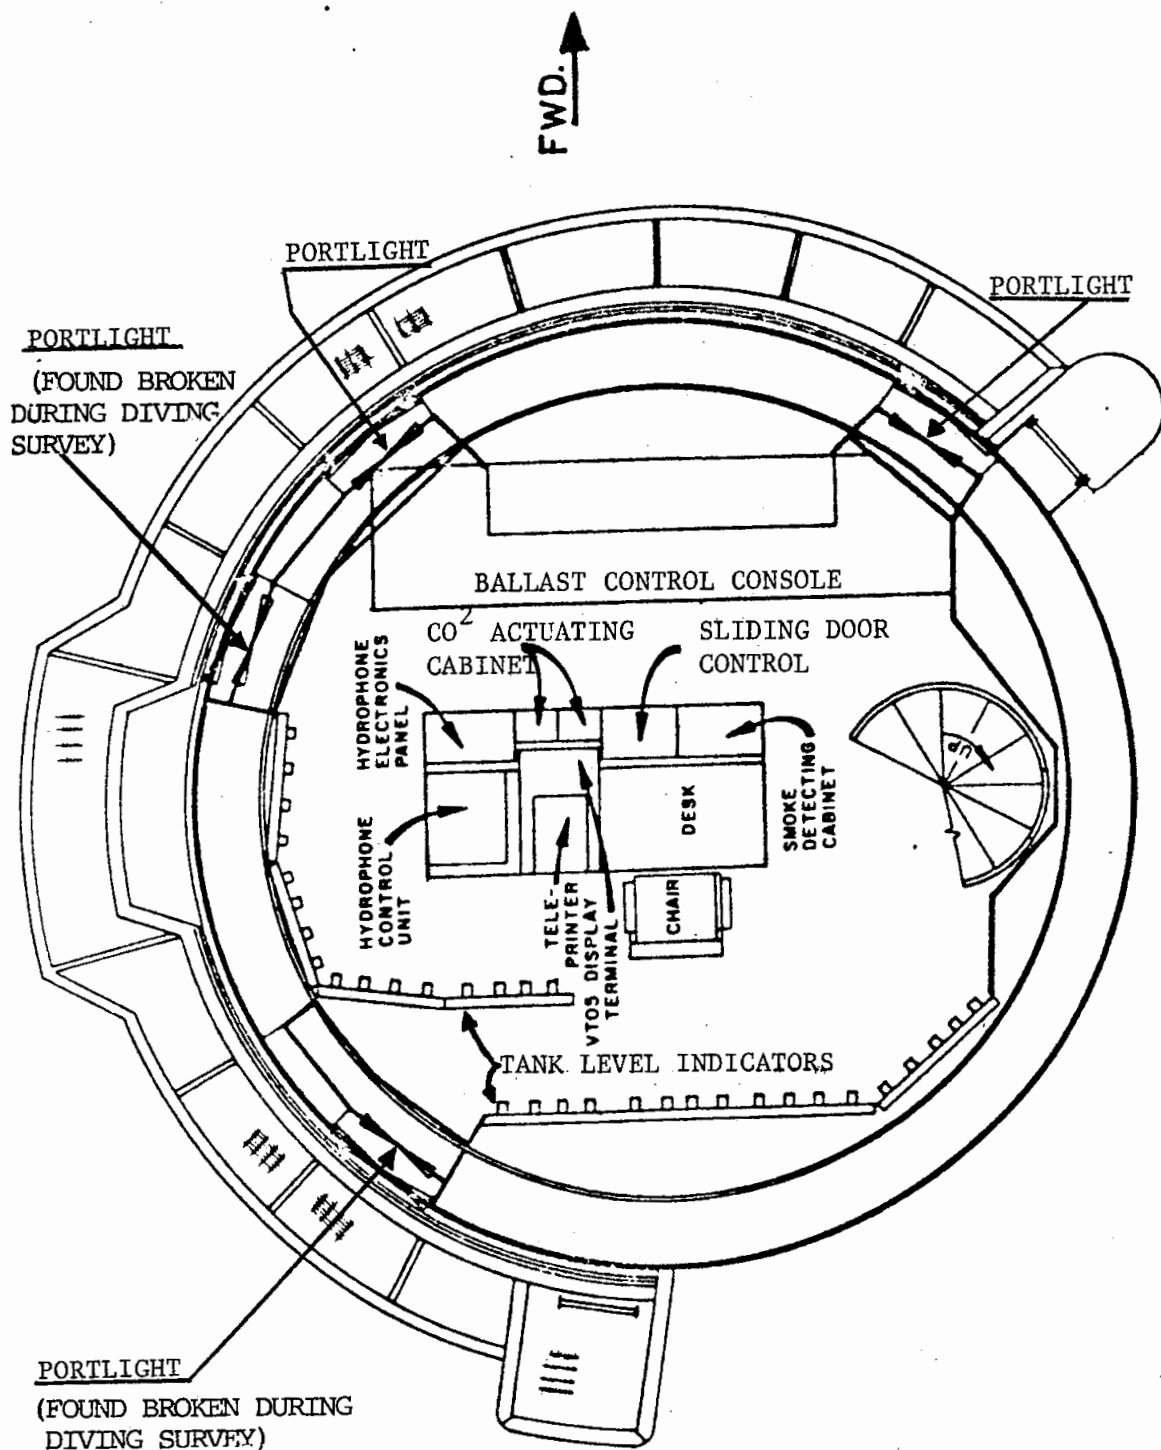
figure 9

BALLAST CONTROL ROOM ARRANGEMENT

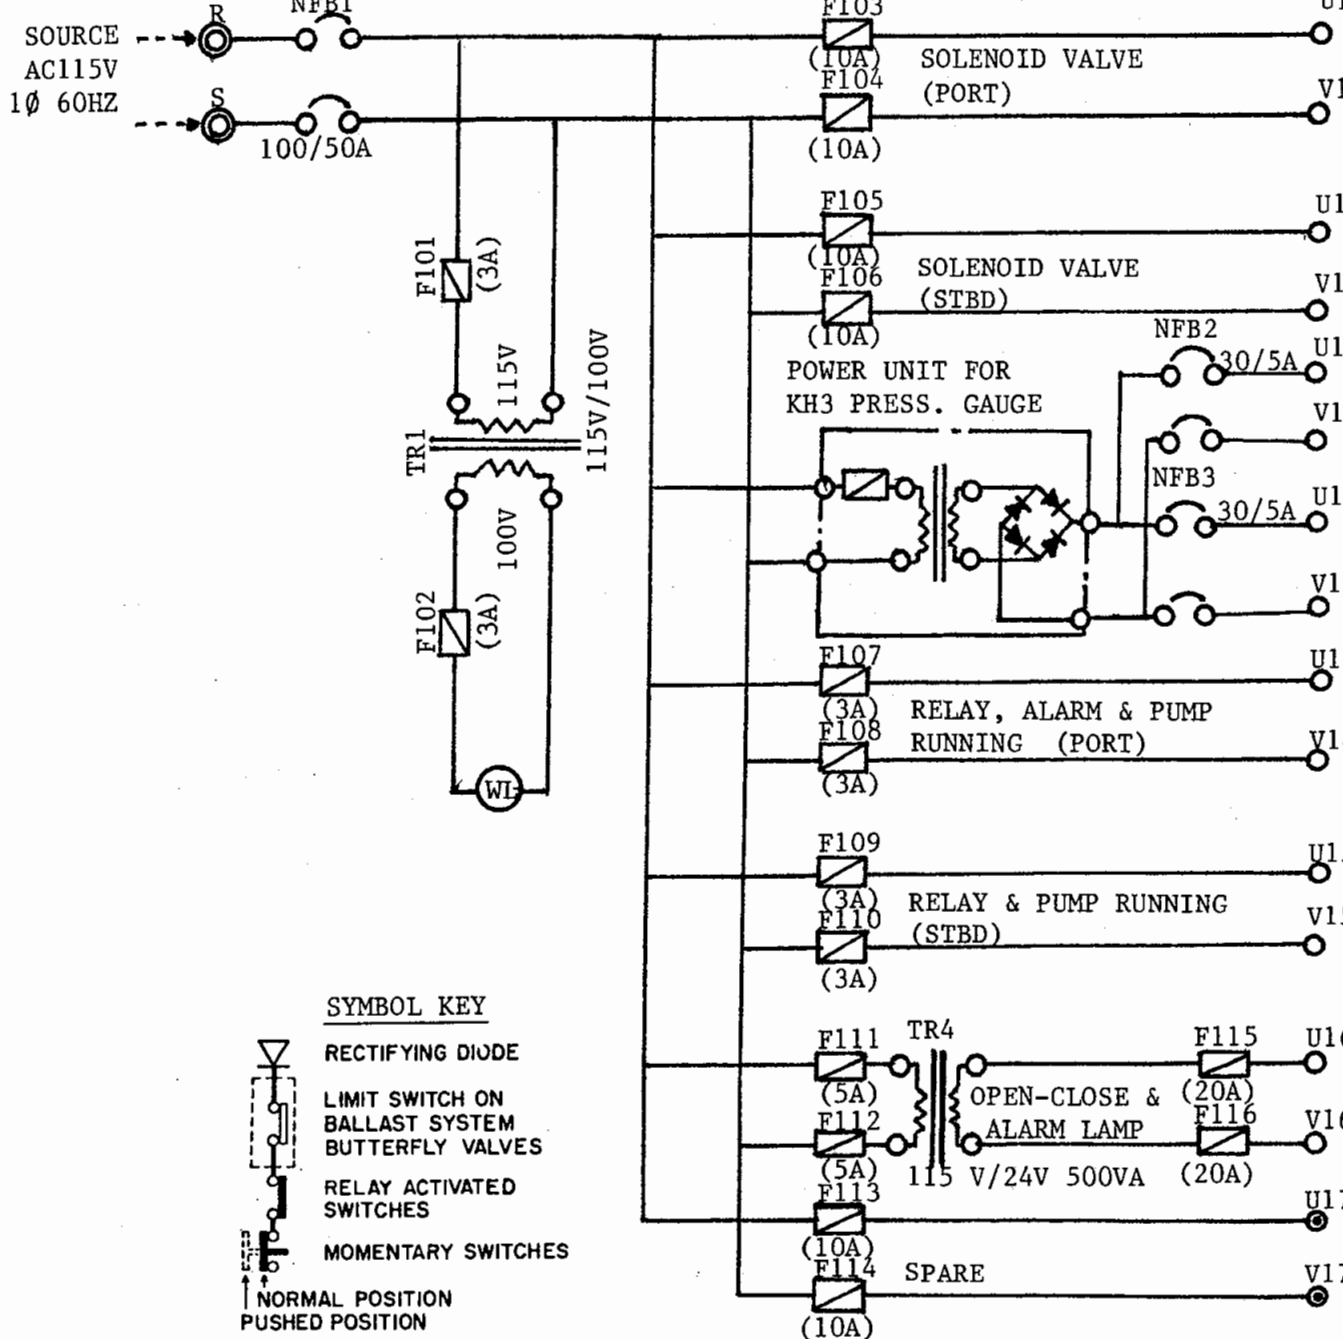
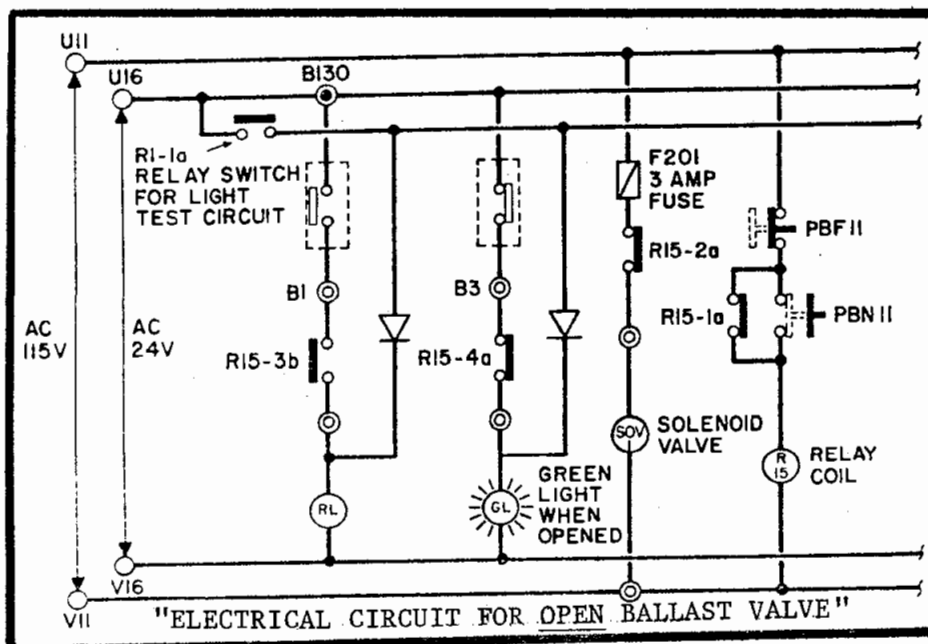
FIGURE 11
POWER LINE CIRCUIT FOR BALLAST CONSOLE

In the event of a loss of electrical power to the control console for any reason, it was possible to activate the air solenoids by the insertion of brass actuating rods. Witness testimony indicated that these rods were normally stowed inside the console. Air solenoid valve actuation was effected by inserting and threading these rods into an opening in the solenoid. An examination of an actual air solenoid valve assembly by the Board disclosed that it was not readily apparent at what point the rod had been threaded into the bushing sufficiently to cause the valve to open. In addition to manually actuating the air solenoid valves with the brass rods, the ballast valves could be physically opened in the ballast pumprooms by turning each valve stem with a wrench, compressing the operating assembly spring.

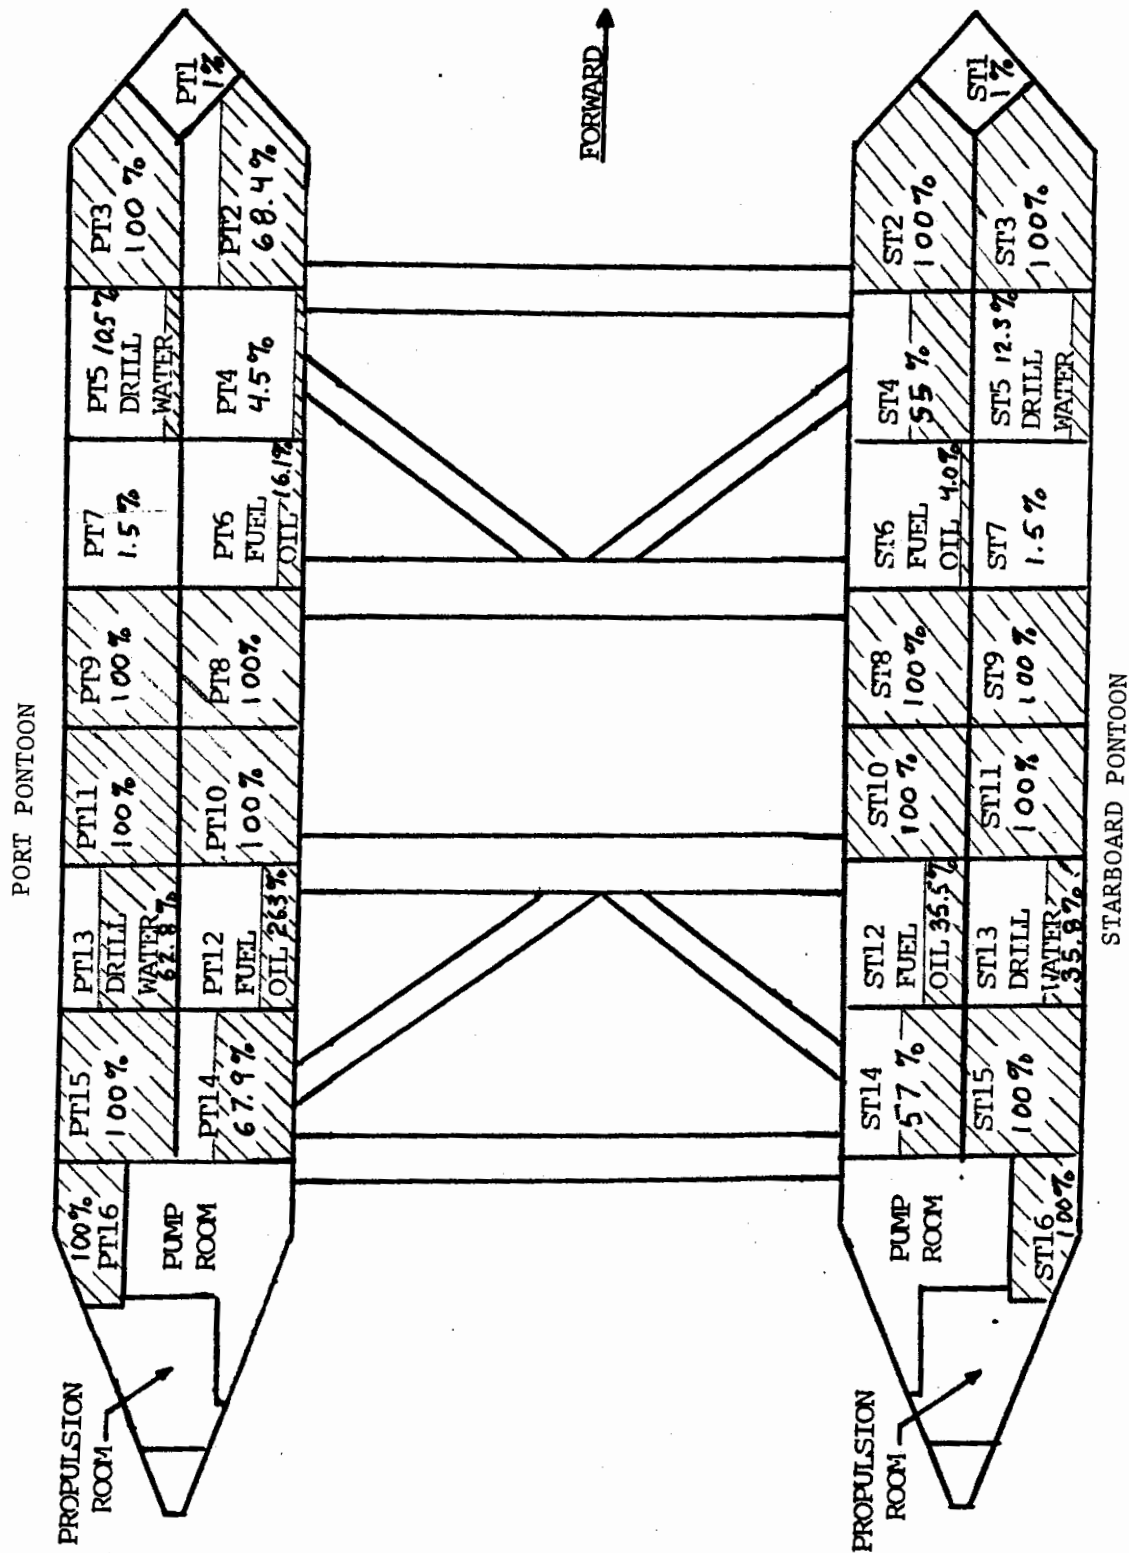
Figure 15: PERCENTAGE OF LIQUIDS IN OCEAN RANGER PONTOON TANKS, MORNING OF 14 FEBRUARY 1982

Figure 15 depicts the liquid levels in the ballast tanks on 14 February 1982 as indicated in the weekly ballast report work sheets recovered from the OCEAN RANGER. The report indicated that the after ballast tanks used for adjusting trim, PT 14 and ST 14 were respectively 67.9% and 57.0% of capacity. The ullage provided a potential moment to correct trim of 58,000 foot/long tons (F/LT). During the evening, the control panel was doused with sea water entering a broken porthole causing an actual or perceived panel malfunction. At the time of malfunction or when personnel attempted to correct the malfunction, the OCEAN RANGER either took water into the ballast tanks or water shifted to the forward tanks, or both, causing a list by the bow. At some point, the crew had taken the measure of closing the two manually operated sea inlet gate valves. Evidence indicates the rig may have had a 10 degree list for a period of time which the crew believed had stabilized. An approximate moment of 17,000 (F/LT) was required to cause a 10° trim by the bow.

This moment is equivalent to the transfer of 80 LT of water from ballast tank PT 16 to ballast tank PT 1. More likely, the list was caused by the simultaneous transfer of water from several of the full tanks aft to forward empty tanks that provided the 27,000 F/LT moments. Later the list was reported to be 10 to 12 degrees and the last report list before abandoning the rig the list was reported to be 12 to 15 degrees. It was also apparent that manual control of the solenoid activated air valves in the control panels was attempted as a means of opening the ballast valves. Figure 16, page 112, shows the solenoid valves and the extent that the brass rods were used at the time they were recovered by divers. No specific logic can be attributed to the position of the brass rods except that their use indicated the control panel electric circuits were not useable or perceived to be unuseable and an attempt was being made to pump ballast. However, none of the rods were in a position to activate the ballast pump manifold valve or ballast pump discharge valves. It is also possible that brass rods were being inserted in the solenoid valves in preparation to use the pumps. Seventeen of the rods were screwed in all the way against the solenoid valve plunger which would have opened the air valve allowing activation of a ballast valve unless control air had been purposely cutoff. One rod was screwed partway in. Given the ballast control room operator's, Master's, and electrician's inexperience, they may not have realized how far to screw in the rods without opening the solenoid valve. A practiced sense of feel would have been required to do this properly. The opening of the 17 solenoid valves would have resulted in gravitation of ballast to the bow increasing the list to the severe condition which caused the OCEAN RANGER personnel to abandon the rig. It is not known if they operated any of the butterfly valves manually in the pump room. This procedure would have depended on the P.A. system or walkie talkie for communication.
